**Sample Association
Low-Rise Condominium
*Anywhere, TX***

Report #: 17918-0
Beginning: January 1, 2025
Expires: December 31, 2025

RESERVE STUDY
"Full"

October 25, 2024

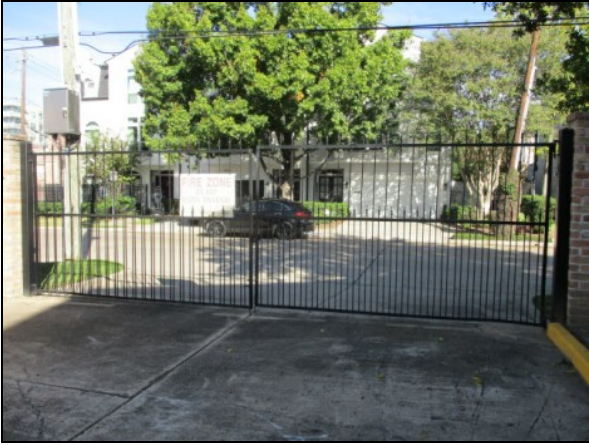
Comp #: 704 Gates - Vehicular (Fire) - Replace

Fair condition: Exhibited minor to moderate corrosion and rust. Hardware showed some wear but connections and supports appeared to be secure.

Useful Life:
30 years

Remaining Life:
12 years

We strongly recommend regular inspections, maintenance and repairs to help extend useful life cycles. Clean for appearance and paint/touch-up as needed within general operating/maintenance funds. Although metal gates are typically durable, we recommend setting aside funding for regular intervals of replacement due to constant wear/usage, exposure and vehicle damage. Replacement can also be warranted for aesthetic changes over time. Plan to replace at roughly the time frame shown below.

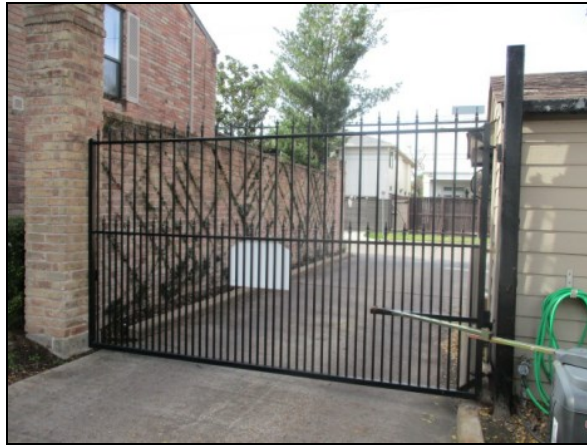
Comp #: 704 Gates - Vehicular (Resident) - Replace

History: Replaced in approximately 2020 (per information provided)

Good condition: Exhibited a uniform finish, functioning hardware, and supports which appeared firm and secure. Overall appearance upholding aesthetic standards for the development.

Useful Life:
30 years

Remaining Life:
25 years

We strongly recommend regular inspections, maintenance and repairs to help extend useful life cycles. Clean for appearance and paint/touch-up as needed within general operating/maintenance funds. Although metal gates are typically durable, we recommend setting aside funding for regular intervals of replacement due to constant wear/usage, exposure and vehicle damage.

Replacement can also be warranted for aesthetic changes over time. Plan to replace at roughly the time frame shown below.

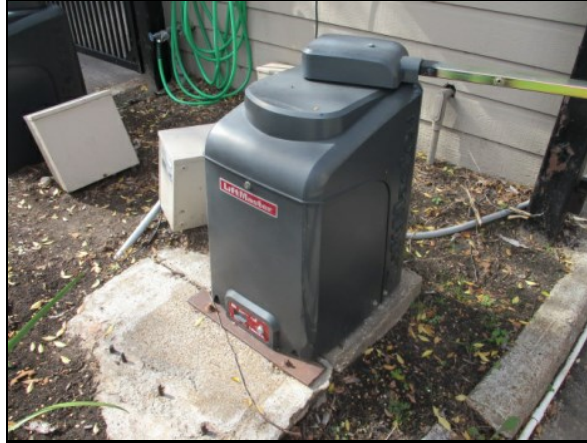
Comp #: 705 Gate Operators - Replace

Useful Life:
10 years

Remaining Life:
5 years

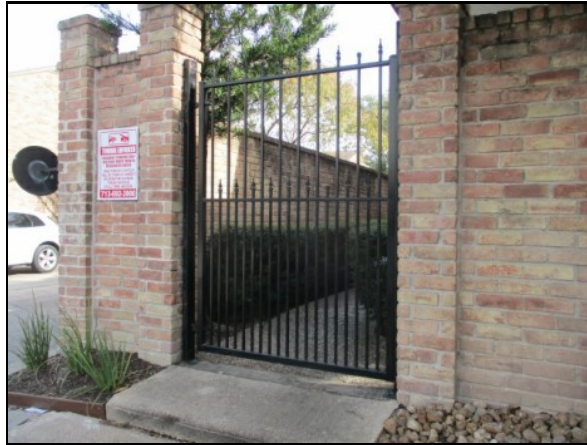
Comp #: 706 Gate - Pedestrian - Replace

History: Replaced in 2024 at an approximate cost of \$5,000 (per information provided)

Useful Life:
25 years

Remaining Life:
24 years

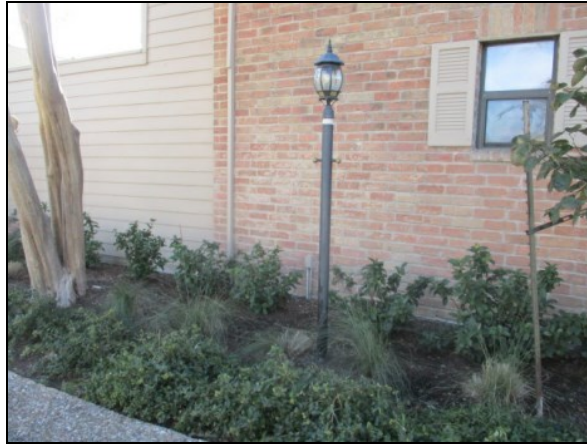
Comp #: 346 Lighting - Site - Replace

Useful Life:
20 years

Remaining Life:
6 years
