Sample Association
Mid-Rise
Anywhere, CA

Report #: 17918-6
Beginning: January 1, 2025
Expires: December 31, 2025

RESERVE STUDY
Update "With-Site-Visit"

October 25, 2024

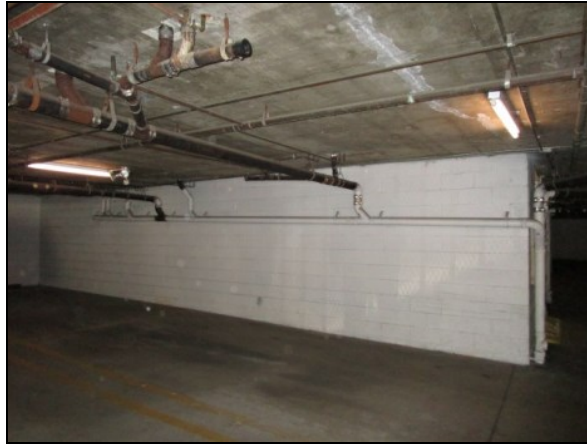
Comp #: 325 Ceiling Lights - Replace

Useful Life:
30 years

Remaining Life:
0 years

Lower estimate to replace

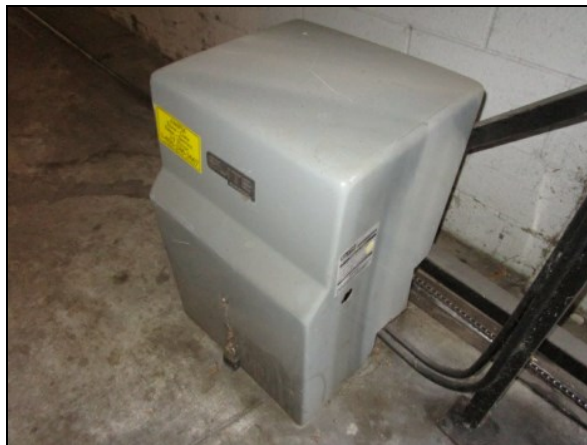
Comp #: 705 Gate Operators - Replace

Useful Life:
15 years

Remaining Life:
0 years
