**Sample Association
Low-Rise Condominium
*Anywhere, TX***

Report #: 17918-0
Beginning: January 1, 2025
Expires: December 31, 2025

RESERVE STUDY
"Full"

October 25, 2024

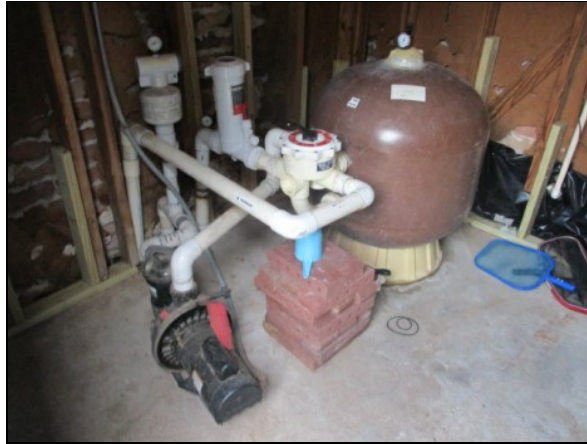
Comp #: 1219 Pool Equipment – Partial Replace

Minimal or no subjective/aesthetic value for pool and spa equipment. Pool and spa pumps, filters, chemical feeders, and other miscellaneous equipment can be repaired or replaced for relatively low cost in most cases. Minimal or no subjective/aesthetic value for pool and spa equipment. Based on evident conditions and/or information provided during this engagement, the Client anticipates full replacement of the equipment (and enclosures as applicable) at the approximate interval shown below. Cost shown below is based on replacement with similar quantity and size of equipment/enclosures, and may include a small allowance for new piping, valve replacements, and other repairs to be conducted as needed.

Lower allowance to repair/replace
