Sample Association
Mid-Rise
Anywhere, CA

Report #: 17918-6
Beginning: January 1, 2025
Expires: December 31, 2025

RESERVE STUDY
Update "With-Site-Visit"

October 25, 2024

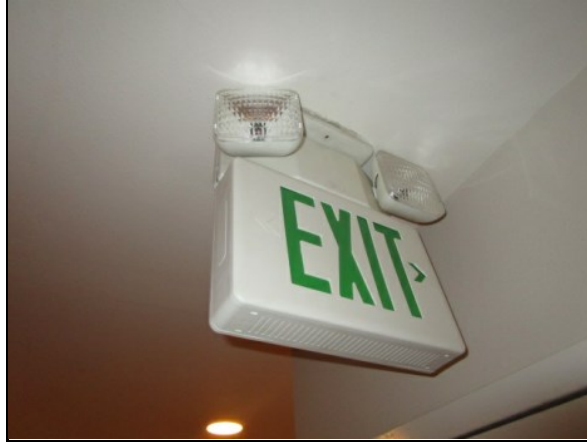
Useful Life:
20 years

Remaining Life:
2 years

Lower estimate to replace

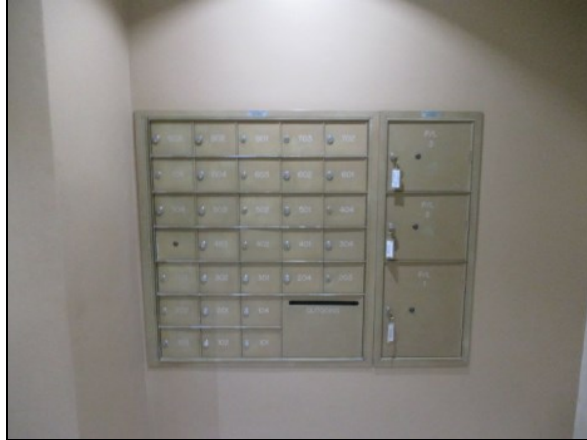
Comp #: 403 Mailboxes - Replace

2017: Mailboxes replace at an approximate cost of \$11,128 (per information provided)

The mailboxes are intact and functional. No signs of advanced deterioration or abuse. Funding for periodic replacements to maintain security and reliability.

Useful Life:
30 years

Remaining Life:
12 years

Lower estimate to replace with similar boxes,
similar style/finish

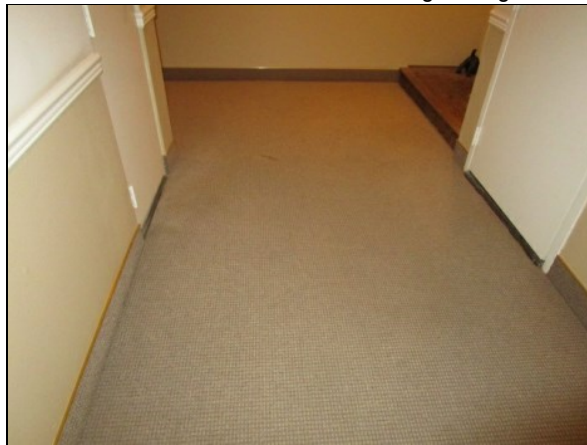
Comp #: 601 Carpet (Hallways) - Replace

Comments: The carpeting is in fair condition overall. Areas of minor staining. No signs of fraying or significant wear.

Useful Life:
10 years

Remaining Life:
2 years

Lower estimate to replace

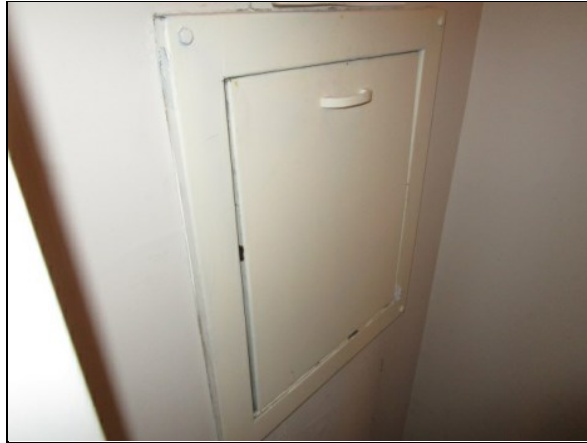
Comp #: 707 Trash Chute Doors - Replace

Comments: Trash chute doors should have a very long useful life under normal circumstances. At long intervals, replacement may be required for aesthetic upgrades. Maintain as needed using Operating funds to ensure good function. Significant wear evident and doors were hard to open, so replacement is recommended at the next hallway remodeling interval.

Useful Life:
30 years

Remaining Life:
2 years

Lower estimate to replace

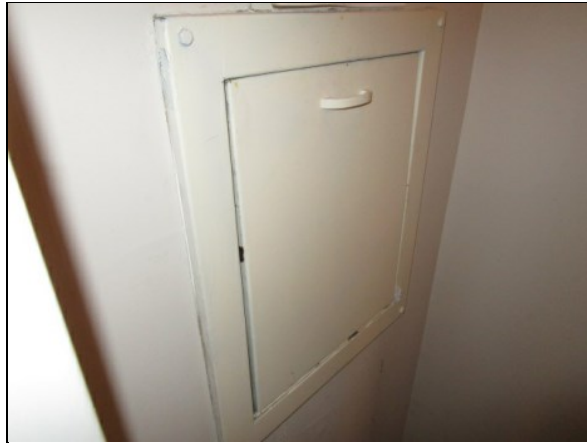
Comp #: 713 Trash Chutes - Replace

Comments: The trash chutes were located at the interior of the building in a protected location. Minimal wear/deterioration evident at the time of inspection. As such, funding has been deemed too indeterminate for Reserve designation at this time.

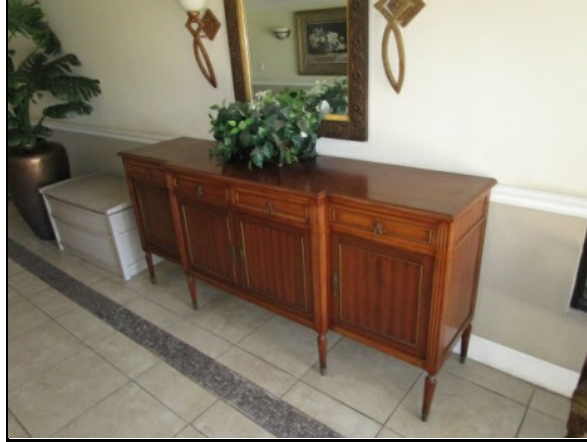
Still in fair or better condition. Heavy traffic through this area, but furniture is just for appearance. Last remodel included new flooring, wallcovering, paint, and furniture. Expect to remodel approx every-other hallway renovation project. .

Useful Life:
20 years

Remaining Life:
12 years

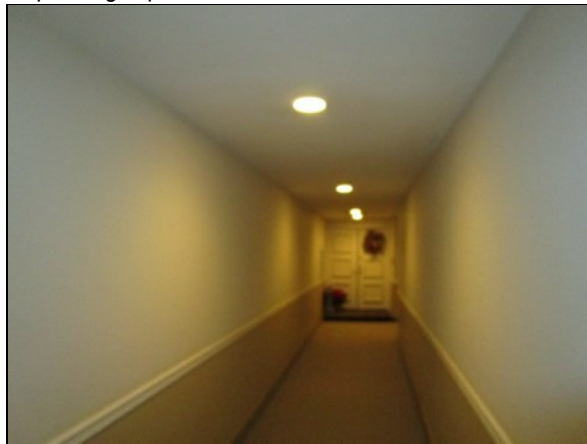
Location: Hallway and lobby walls/trim
Funded?: Yes. Meets the CAI Reserve Study Standards three-part test.
History: Hallway remodeling project completed in 2017 (per information provided)
Comments: Funding for the periodic repainting of the interior common area surfaces to maintain an attractive appearance throughout. These projects should always be coordinated with floor replacement projects whenever possible. Repainting should always be completed before the floor replacement projects to avoid damaging new surfaces. Any minor touch-up repainting projects should be handled as an Operating expense.

Useful Life:
10 years

Remaining Life:
2 years

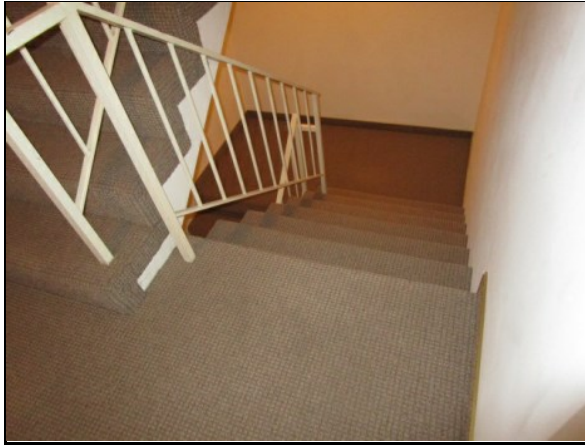
Comments: Funding for interior painting and carpeting replacements have been included within separate components of this report (#601, #1110). In addition, the life expectancy of interior railing replacements has been deemed too indeterminate for Reserve funding at this time. As such, no funding has been incorporated within this component.

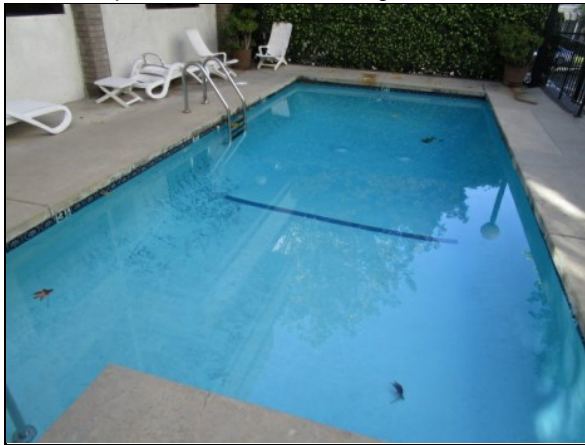
Plaster is showing heavy surface wear. Tiles are unattractive and deteriorated. Poor condition. Funding for the replastering of the pool surfaces every 10-15 years, and the replacement of the tile at longer intervals.

Useful Life:
12 years

Remaining Life:
0 years

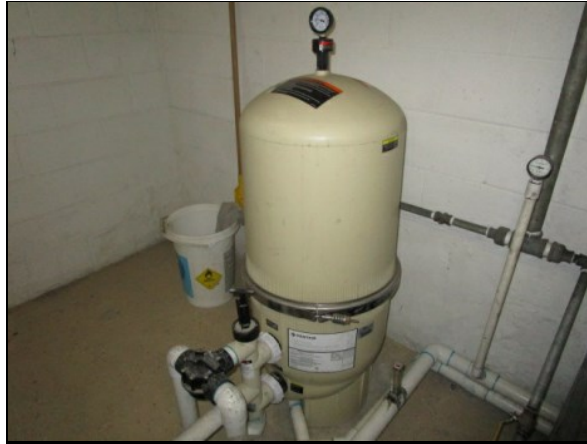
Comp #: 1207 Pool Filter - Cartridge - Replace

Location: Pool equipment room
Funded?: Yes. Meets the CAI Reserve Study Standards three-part test.
History: Replaced in 2014 (per information provided)
Comments: Manufacturer: Pentair
Serial Number: 01922891355493

No signs of staining or active leakage. Good general condition.

Useful Life:
12 years

Remaining Life:
1 years

Lower estimate to replace

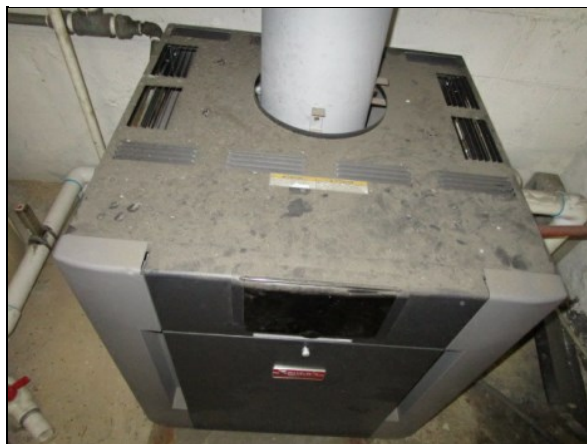
Comp #: 1208 Pool Heater - Gas - Replace

Location: Pool equipment room
Funded?: Yes. Meets the CAI Reserve Study Standards three-part test.
History: Replaced in 2018 (per evident tag information)
Comments: Manufacturer: RayPak
Size/Capacity: 275,000 BTU/hr
Manufacture Date: 2018

Useful Life:
10 years

Remaining Life:
3 years
